Appendix B  
The Commonwealth of Massachusetts  
Executive Office of Health and Human Services  
Department of Public Health  
250 Washington Street, Boston, MA 02108-4619

August 4, 2005

At the request of a parent and in cooperation with Sandra Martin, Great Barrington Board of Health, the Center for Environmental Health (CEH) conducted an evaluation of the indoor air quality at the Muddy Brook Regional Elementary School (MBRES), Monument Valley Road, Great Barrington, Massachusetts on July 29, 2005. Michael Feeney, Director of CEH's Emergency Response/Indoor Air Quality (ER/IAQ) conducted this evaluation. Concerns about mold as a result of excessively humid weather during the month of July 2005 prompted the request for a building assessment. As reported to MDPH staff, a musty odor exist was detected on the first floor of the building during hot, humid weather after school classroom materials were moved into the building. Classrooms were examined on each floor in both wings of the building by MDPH staff. The band room had detectable musty odors, however no other rooms had similar odors. The musty odor in the band room was traced to a variety of instrument cases that were found wi

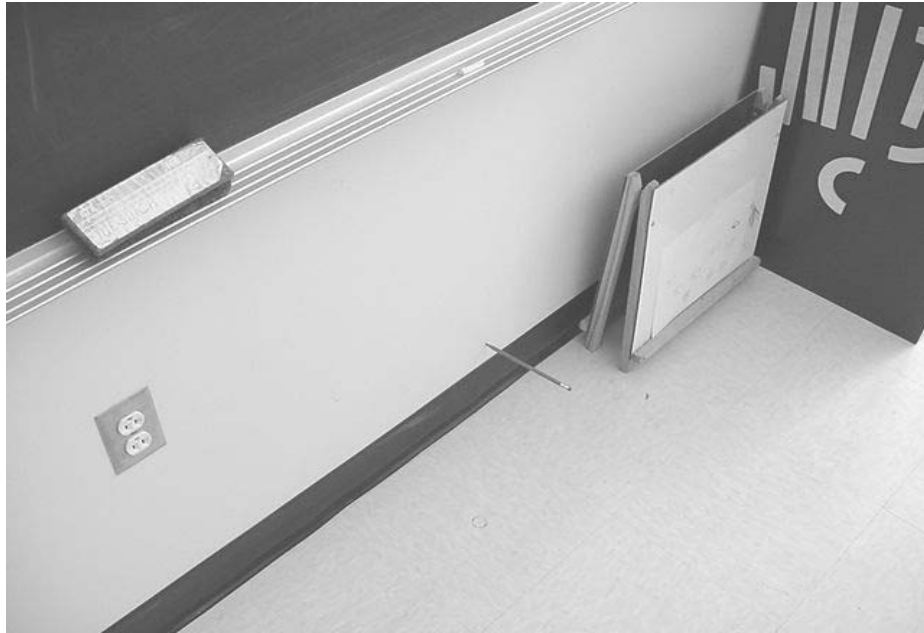
**Picture 1**

During the course of the MDPH assessment, gypsum wallboard (GW) and ceiling tiles were examined. No mold colonies were observed on these materials. Moisture sampling throughout the MBRES found moistened GW in an exterior wall of the OP/PT room, next to the music room; however, no musty odor was detected in this room. The softness of the GW (Picture 1) combined with the moisture sampling indicated that this wall appears to be chronically water damaged, most likely from water penetration through the exterior wall. The last appreciable rainfall in the general Great Barrington area occurred July 27, 2005, two days prior to the MDPH visit to the school.

**Moistened Gypsum Wallboard in OP/PT Room**

In this condition, this exterior wall is subject to chronic water exposure. This condition is likely playing a role of either providing a direct moisture source or creating conditions that would result in the production of condensation within the wall space. The GW in the OP/PT room should be removed and the source of the moisture be remediated.

4. Discard porous materials that are contaminated with mold or are water damaged (e.g. musical instrument cases and GW in the OP/PT room).
5. Disinfect non-porous materials (e.g., doorframes, linoleum, cement, Lucite topped metal desks and chairs, wood surfaces) with an appropriate antimicrobial agent. Clean non-porous surfaces with soap and water after disinfection. As soon as this second cleaning is completed, use fans that introduce air from other clean areas or dehumidifiers to dry cleaned area.

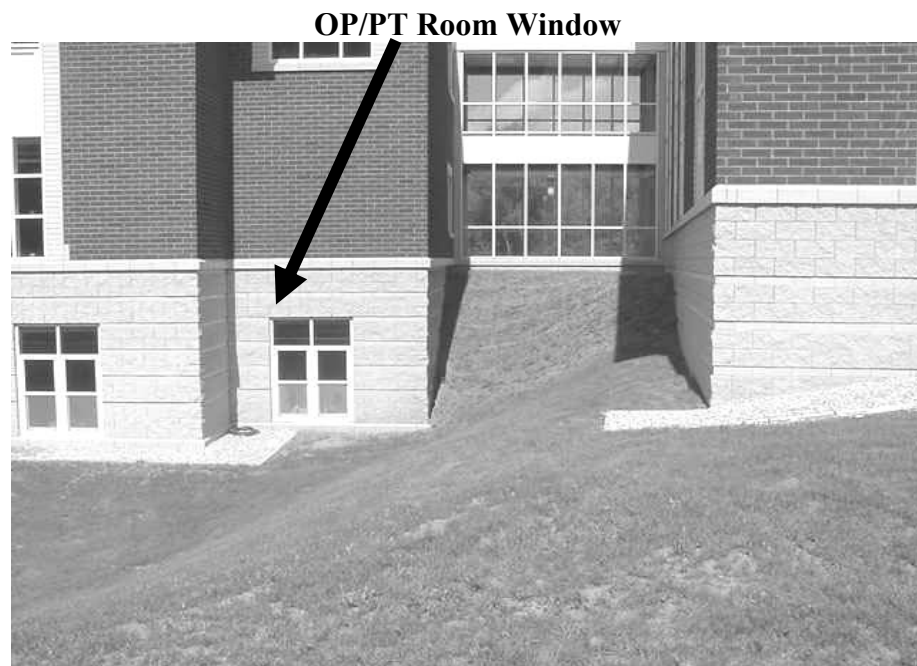
**Picture 2**

The GW in the OP/PT room is affixed to an exterior wall that is partially buried beneath an embankment of soil (Picture 2). Examination of this wall revealed the following conditions that indicate chronic wetting.

**OP/PT Room Exterior Wall Partially Buried Beneath Embankment**

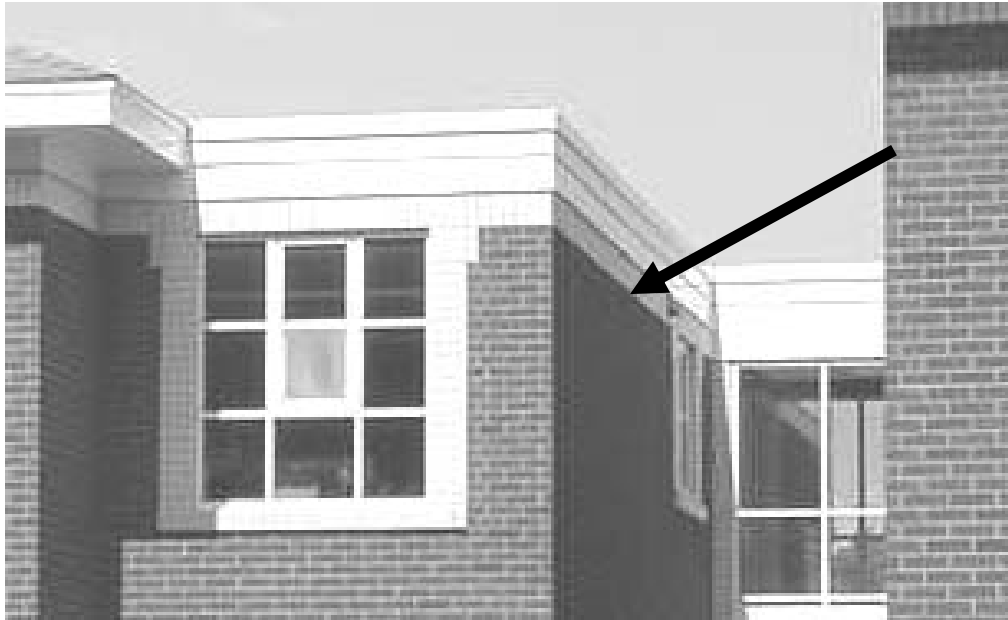
**Picture 3**

- A roof scupper empties on to the top of the embankment (Picture 3). A furrow likely created by erosion by rainwater was noted along the soil/exterior wall junction (Picture 4).
- Brick on the exterior wall was caked with mud 2-3 feet above the ground (Picture 5), likely created by water/mud mixture splashing on this wall. Please note that no other wall of the MBRES exhibits this phenomenon.
- Water is pooling at the base of the embankment [the lack of grass growth in this area versus (Picture 6) versus the lawn along the front of the building (Picture 7) supports this hypothesis].
- GW moisture measurements throughout the MBRES rooms were dry, with the exception of the GW in the OP/PT room.

**Scupper That Drains Excess Water from Roof**

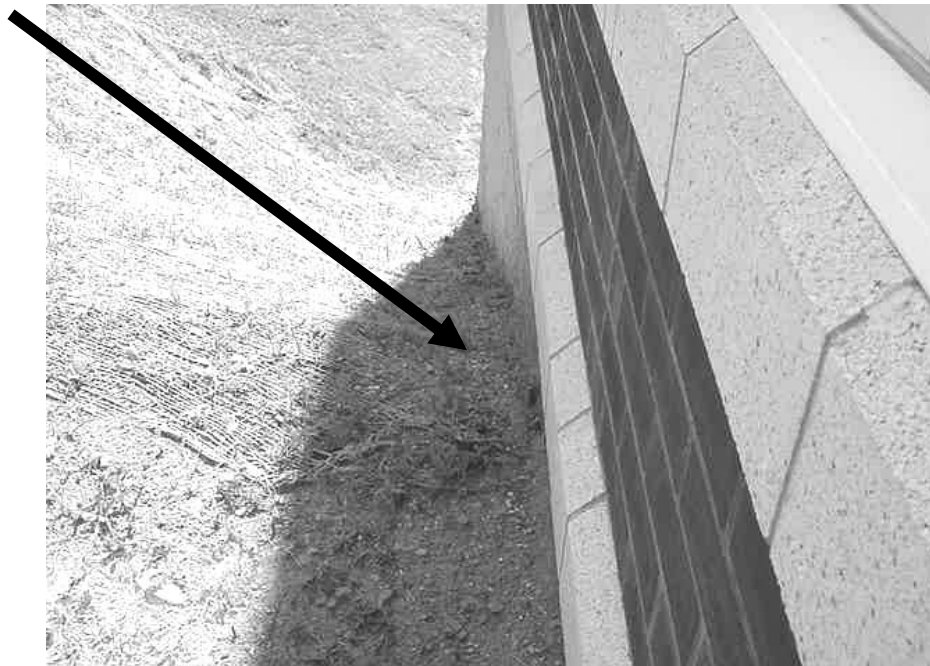
**Picture 4**

**Furrow in Soil along Exterior Wall (Note Eroded Soil at Base of Wall)**

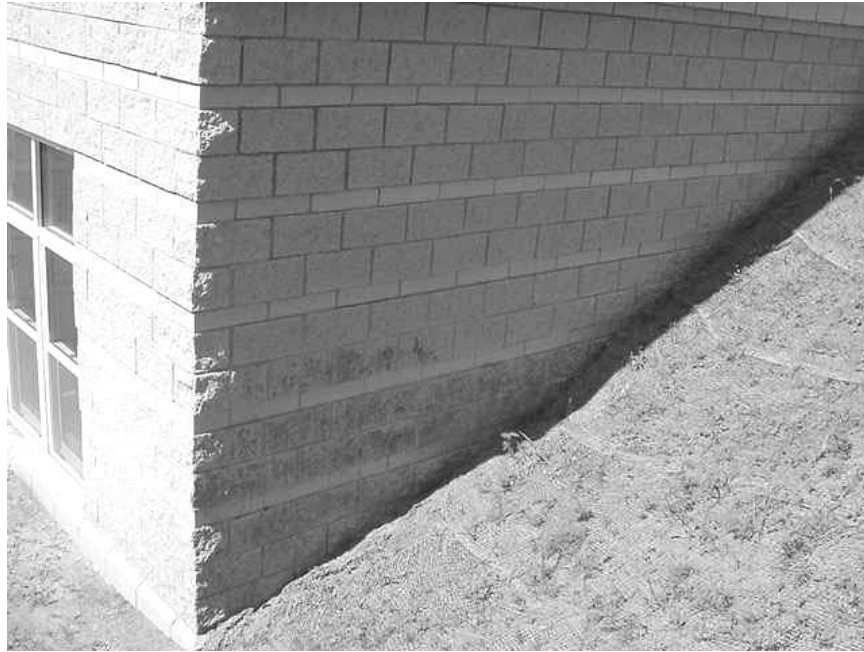
**Picture 5**

**Brick Is Of the Exterior Wall Were Caked With Muddy 2-3 Feet above the Ground**

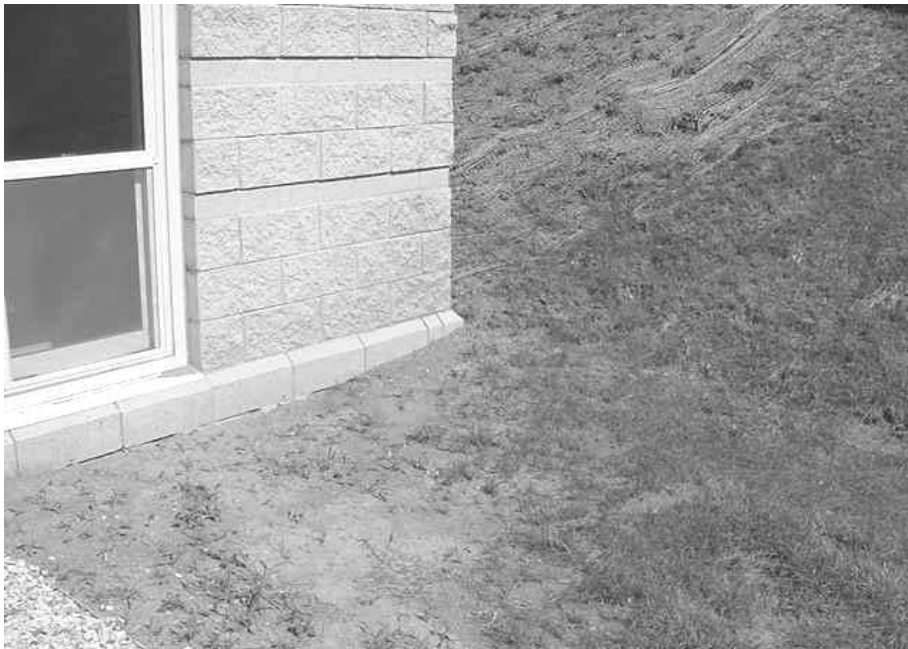
**Picture 6**

**Water Is Pooling At the Base of the Embankment, As Exhibited By the Lack of Grass Growth**

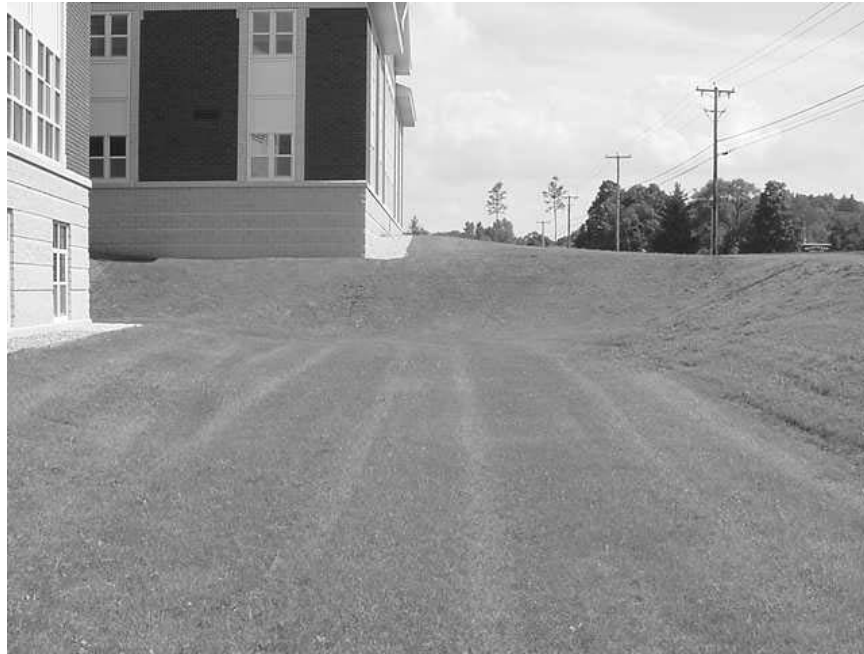
**Picture 7**

**Lawn In Front Of Building, Compare To Picture 4**
